Electric Sauna Heaters

— by Daniel B. Langlois, CET, CFEI Fire Investigator, CSA International

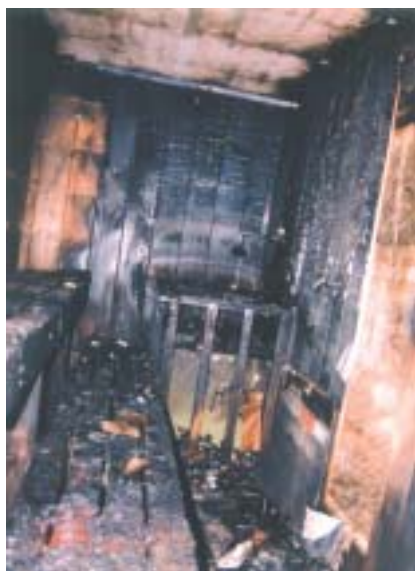
Sauna interior

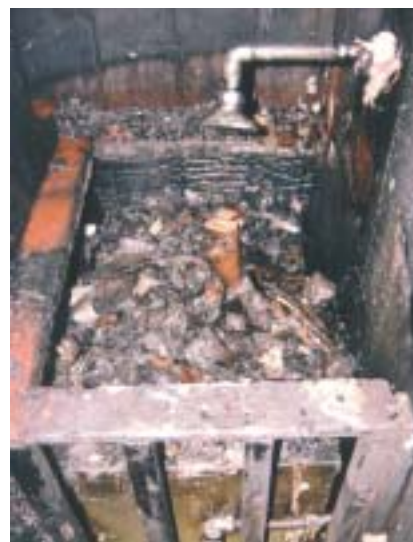
Close-up of sauna heater

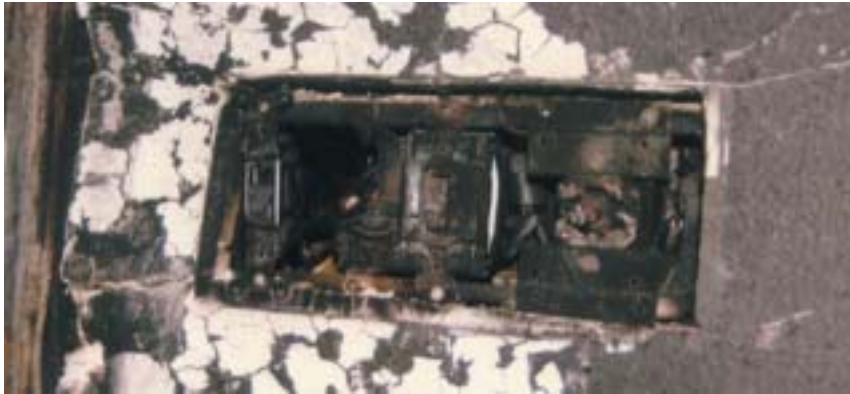
Switch plate: From left to right are the heater switch, the on/off light, the interior sauna light and the temperature control.
